FULL DEPTH RECLAMATION SUCCESS STORY

Indiana Department of Transportation's Unique Rehabilitation of a Major Collector

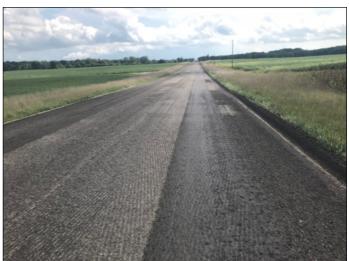
The existing asphalt pavement on SR 101 was experiencing widespread age-related distresses and fatigue. It had an average IRI of 153 in./mi. and 31% of the roadway surface was in "poor" condition. Past chip seals were delaminating and creating potholes. INDOT was performing yearly patching in order to maintain a rideable surface. Other issues throughout the project included rutting up to 1.0-inch deep, lack of a crowned cross slope, and drainage issues. Due to a large number of horse-drawn buggies that travel along the project, there was a concern with the lack of shoulder, INDOT wanted to improve safety for the vehicles passing the buggies.

Pavement sampling revealed bottom-up cracking beginning to propagate to the surface. Delaminated, unbound layers, asphalt stripping, and cracked underlying layers were also observed during sampling. INDOT then performed FWD testing on SR 101 to calculate stiffness-related parameters of the pavement structure. It was discovered that there was also poor subgrade strength below the asphalt pavement. These findings revealed that the project was beyond the point where a single lift HMA overlay would be cost-effective.

Existing Pavement Surface during Investigative Sampling

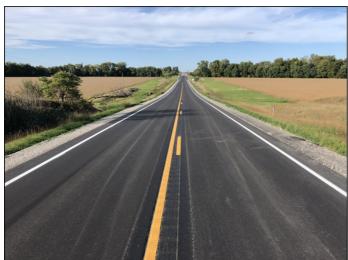
Paving of the 2.0-inch 12.5mm HMA surface
