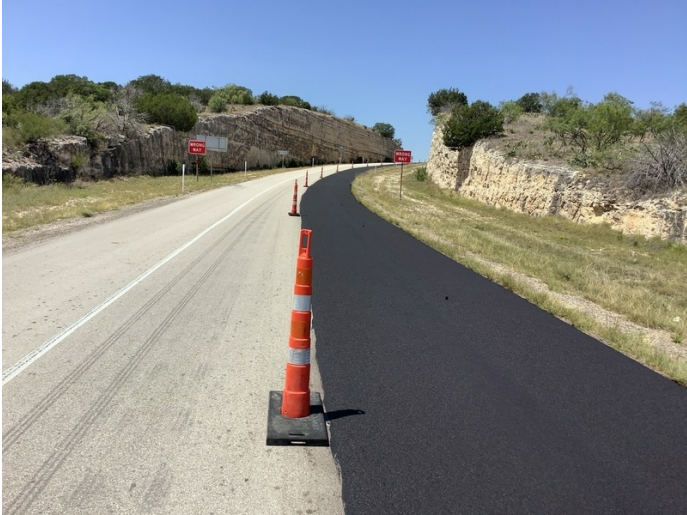
Micro Surfacing is being applied to Interstate I-10 in Ozona, Texas.

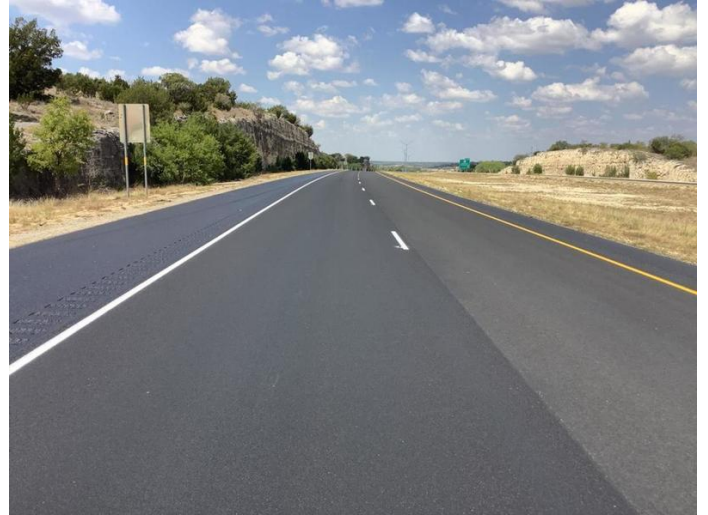
Completed Micro Surfacing project in Ozona, Texas maximized surface friction.
