## Using Optimized Solutions for Extreme Soil Conditions

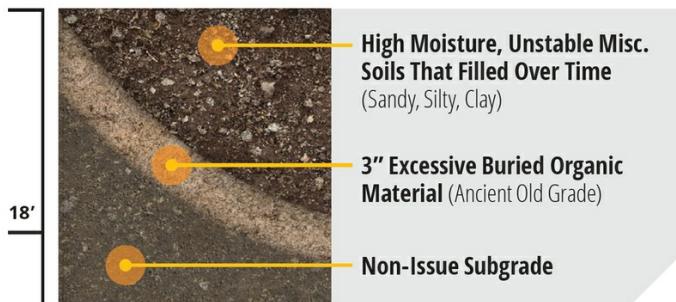
#### THE PROBLEM

##### CURRENT GRADE

Engineers were faced with solving foundation issues caused by improperly placed fill soil with high moisture content that had been placed atop 3' of buried organic material, reaching depths of up to 18'. This combination made standard foundation construction impossible, prompting engineers to explore alternate solutions like every costly caissons or worse yet, total removal and replacement.

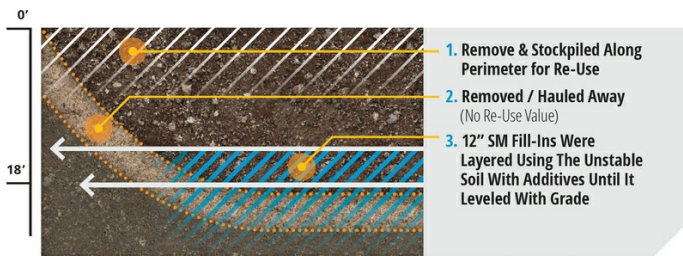
## THE ROCK SOLID SOLUTION

Caissons were originally specified to support the foundation, reaching into the stable subgrade below. This support system would require a non-conventional underground piping and construction process; a method that is known to cause delays and increase construction costs. Rock Solid value-engineered a Soil Stabilization process to re-use existing material and avoid non-conventional construction methods, saving money and time.
