In 2005, Mississippi DOT preserved one of their most heavily trafficked highways, adding 14+ years of life while addressing friction, cracking and rutting-- Today in 2020, the highway has required no further treatments.

In 2005, 12 miles of Highway 61 in Tunica, Mississippi needed reprofiling and preservation due to high traffic (13,000 vehicles per day) leading in and out of their gambling district, the third largest in America.

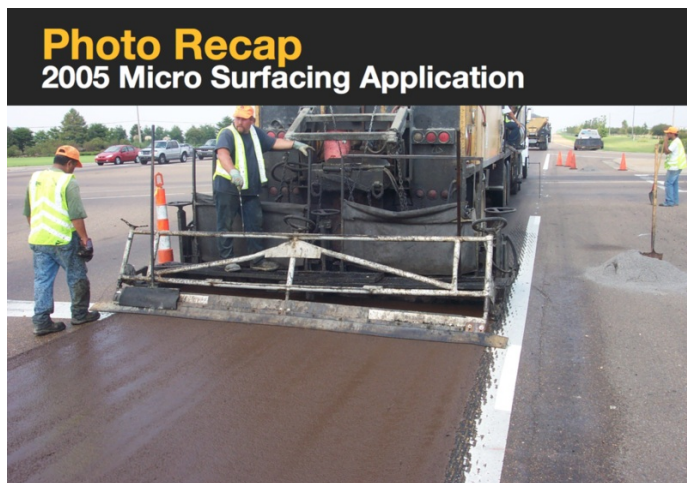
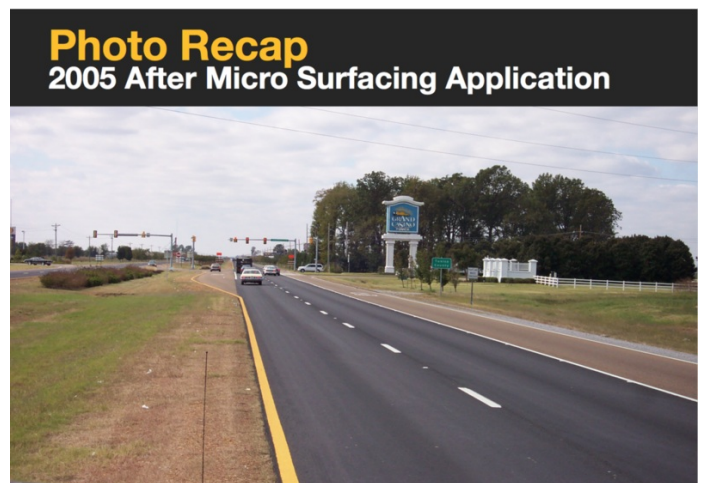
Photo Recap
2005 After Micro Surfacing Application

MDOT worked with Vance Brothers, Ergon Asphalt & Emulsions, and Vulcan Materials Company through devastating weather conditions resulting from hurricane Katrina, to apply micro surfacing in two thin lifts with Type V aggregate and a micro surfacing emulsion (CSS-1HP), applied at 11.0% +/- 1.0%. The optimum emulsion content was engineered to sit on the lower side of the specified range to address rutting.

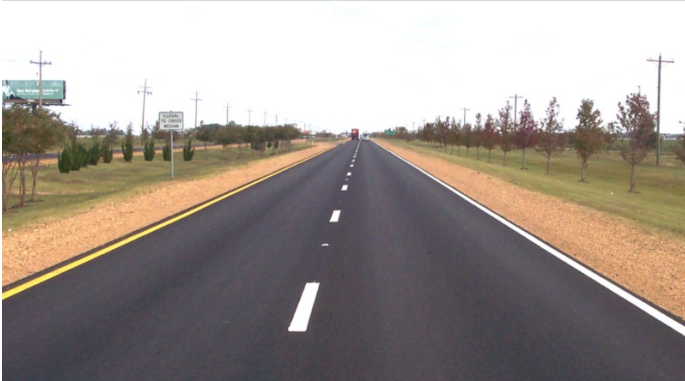
Photo Recap
2005 / 2017 Side-by-Side Comparison

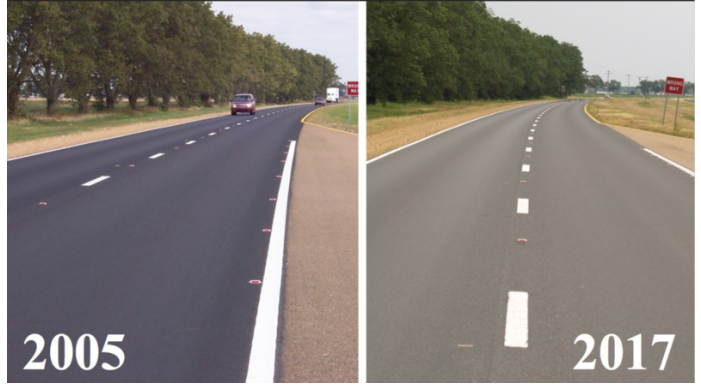
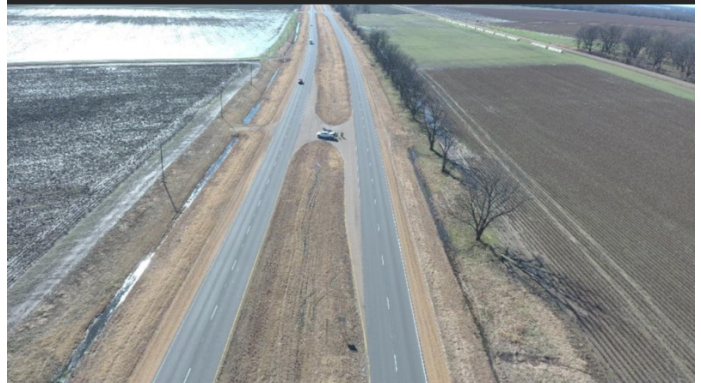
Photo Recap
2020 – Over 14 Years Post Application

This process saved millions of dollars which could be allocated to other needs. Passengers have enjoyed a more durable wearing course which is able to withstand the heavy volumes of traffic. After 14 years the roads continue to hold, requiring no further treatments to date.
