In 2005, Mississippi DOT preserved one of their most heavily trafficked highways, adding 14+ years of life while addressing friction, cracking and rutting-- Today in 2020, the highway has required no further treatments.

In 2005, 12 miles of Highway 61 in Tunica, Mississippi needed reprofiling and preservation due to high traffic (13,000 vehicles per day) leading in and out of their gambling district, the third largest in America.

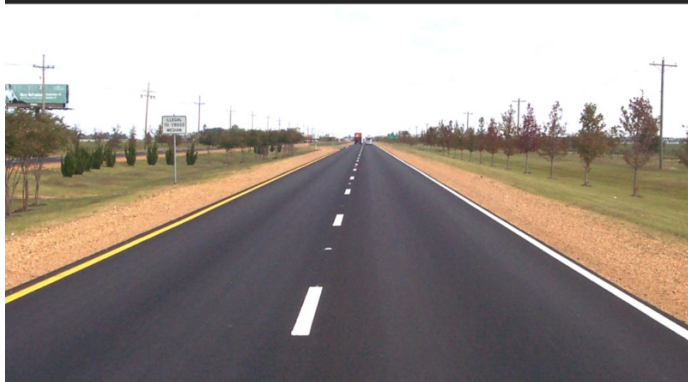
2005 After Micro Surfacing Application

MDOT worked with Vance Brothers, Ergon Asphalt & Emulsions, and Vulcan Materials Company through devastating weather conditions resulting from hurricane Katrina, to apply micro surfacing in two thin lifts with Type V aggregate and a micro surfacing emulsion (CSS-1HP), applied at 11.0% +/- 1.0%. The optimum emulsion content was engineered to sit on the lower side of the specified range to address rutting.

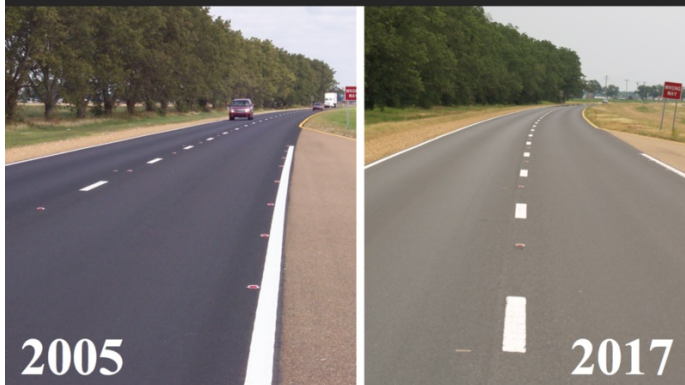
2005 / 2017 Side-by-Side Comparison

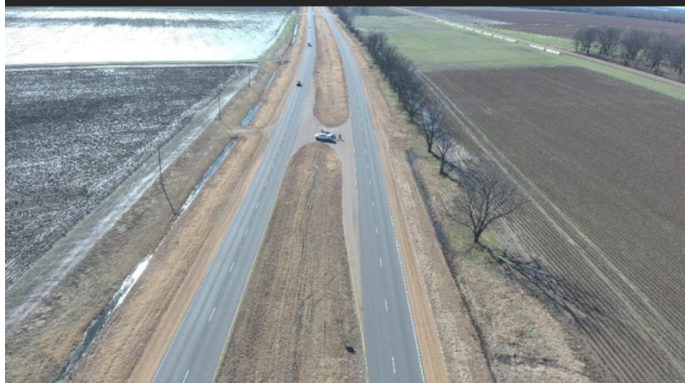
This process saved millions of dollars which could be allocated to other needs. Passengers have enjoyed a more durable wearing course which is able to withstand the heavy volumes of traffic. After 14 years the roads continue to hold, requiring no further treatments to date.

2020 – Over 14 Years Post Application
