Victoria, Australia utilizes pavement preservation techniques for higher quality roads, supporting heavy traffic, with a lower project cost.

**BACKSTORY:**

A section of arterial road in Benalla, Victoria experiences a heavy flow of both commercial and residential traffic, with more than 9,000 vehicles per day. The wear and tear from the high volume of traffic, and the turning and torque of heavy vehicles required a massive maintenance program to repair and extend their lifespan.

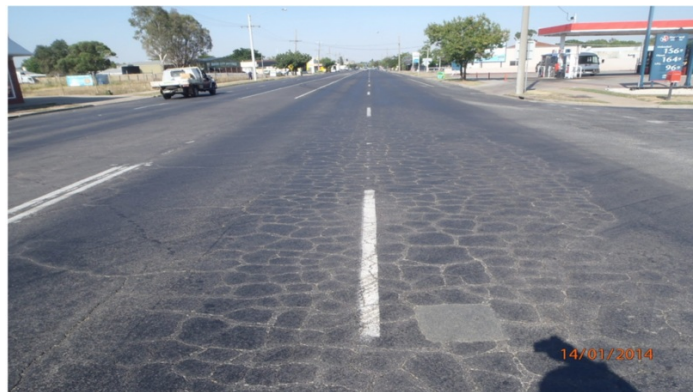
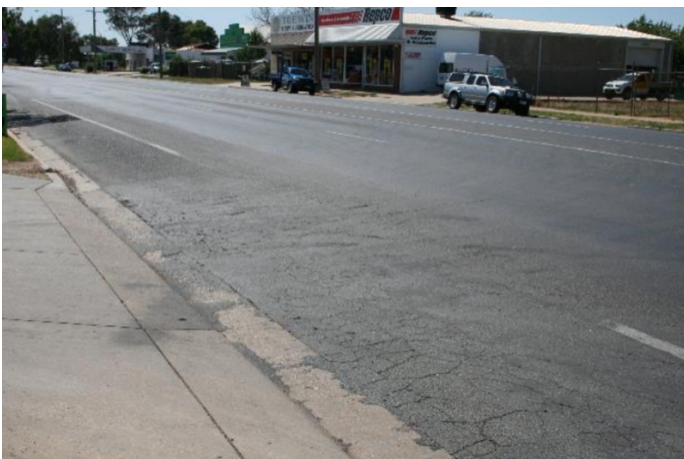
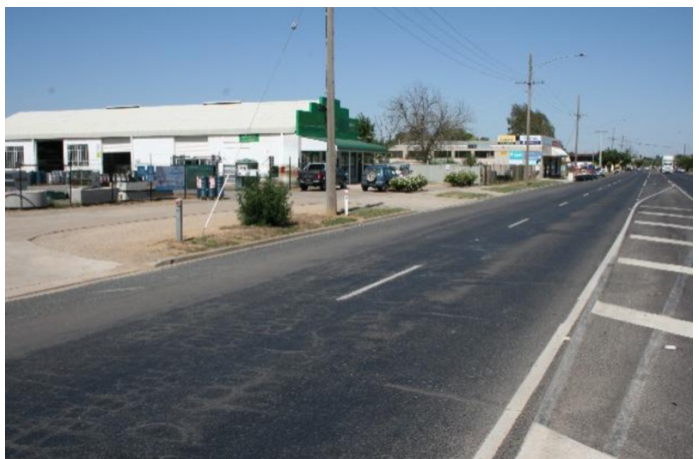
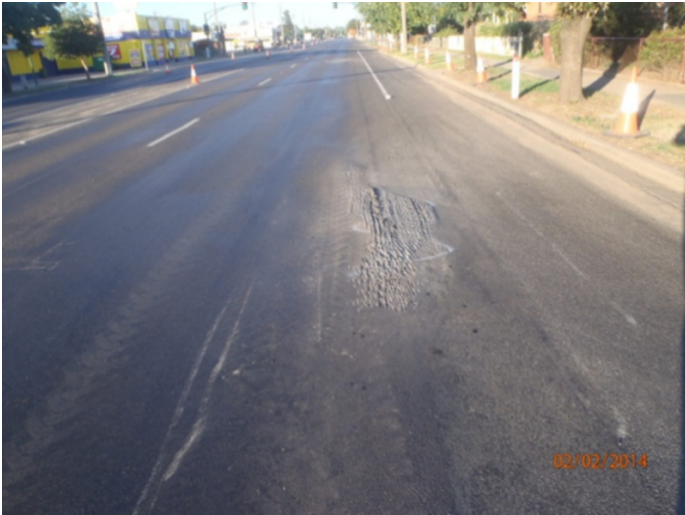
Pre-existing Condition - January 2014

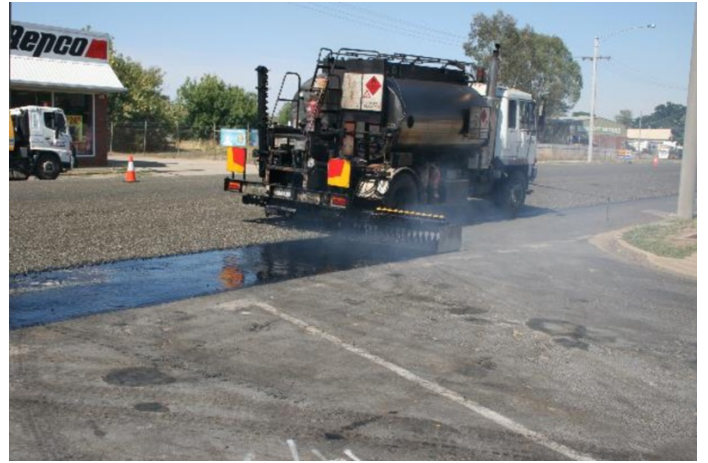
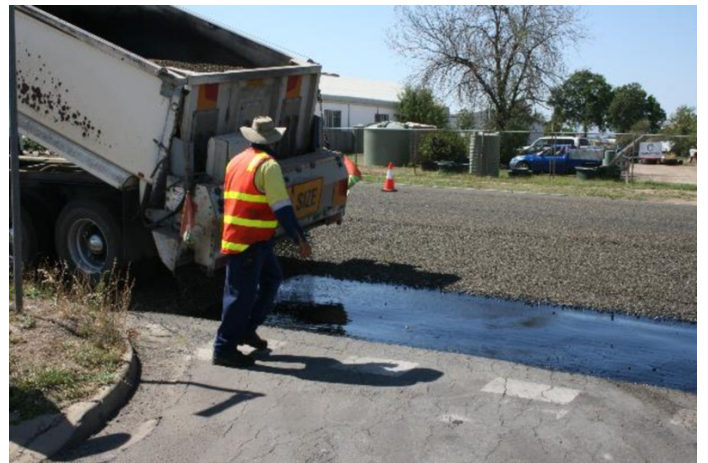
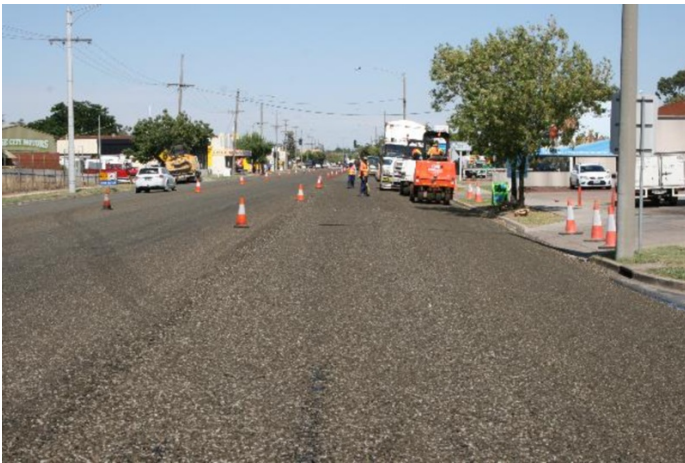
Installing the seal February 2014

North Eastern Maintenance Alliance teamed with Downer Group to provide a preservation treatment using a Polymer Modified Binder (PMB) Spray Seal, overlaid with a Microsurfacing SFT (Suspended Fibre Technology) Cape Seal, cutting expenses, emissions and time. This type of treatment provided a cost effective, highly flexible, waterproof film coupled with a hard wearing surface to accommodate high volumes of vehicles, turning traffic and sound reduction. Six years after completion, the road is maintaining a high condition with minimal wear.

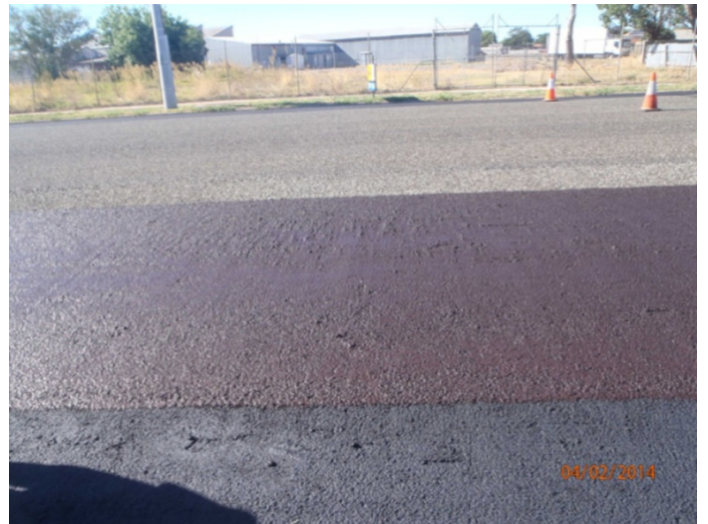
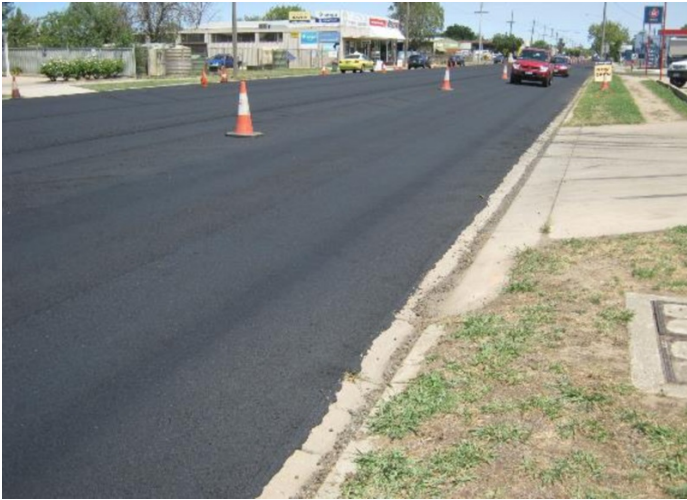
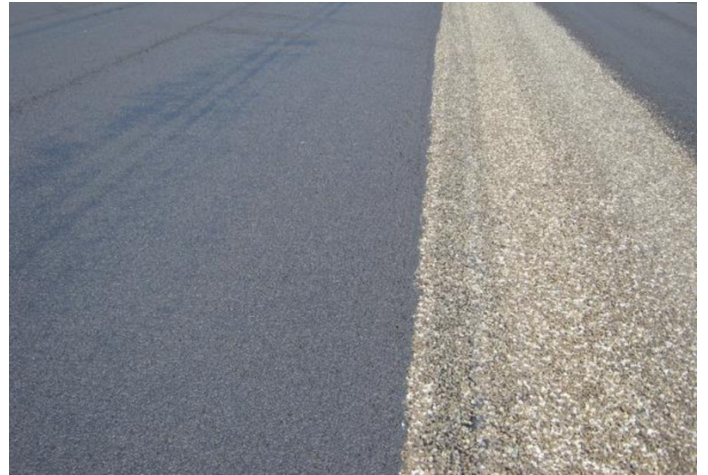
Installing the Micro Surfacing

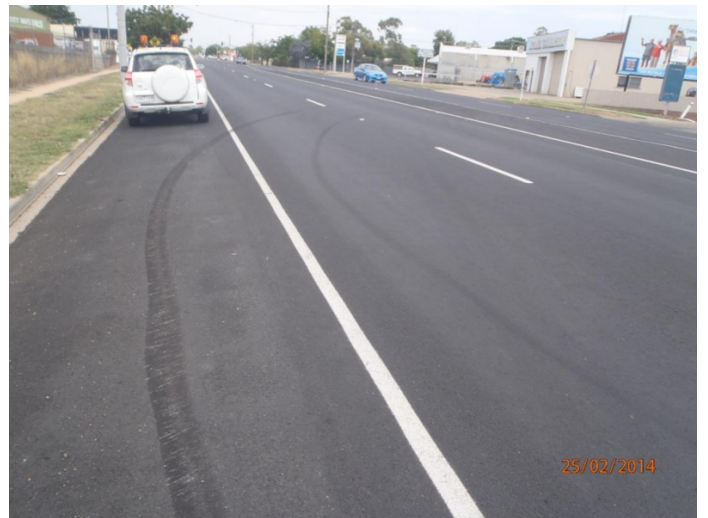
Completed Surface 2014

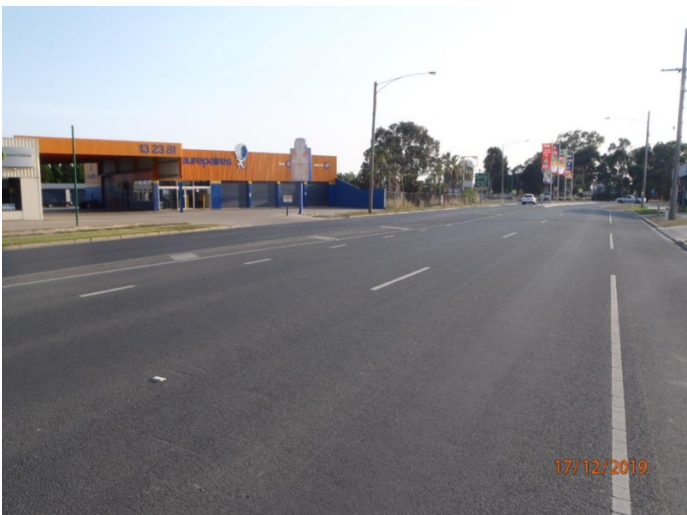
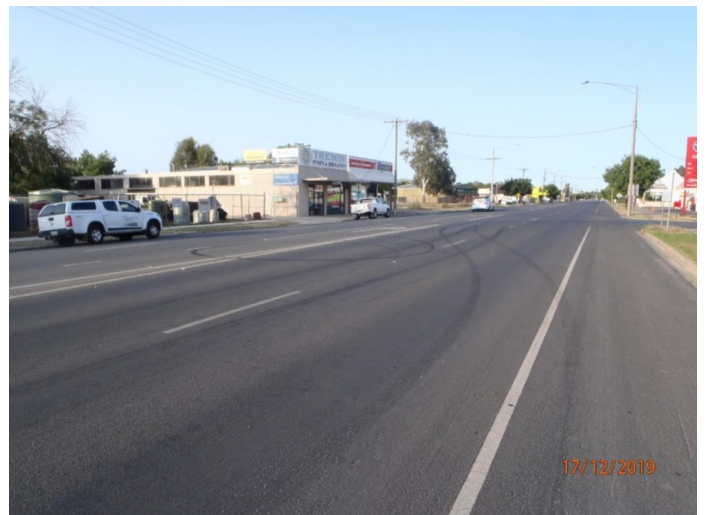
Performance Review December 2019
