Contractor successfully repaired Lake Louise Marie Road in the Town of Thompson located in Sullivan County New York. Fiber reinforced interlayer with a Paver Placed Surface Treatment overlay.

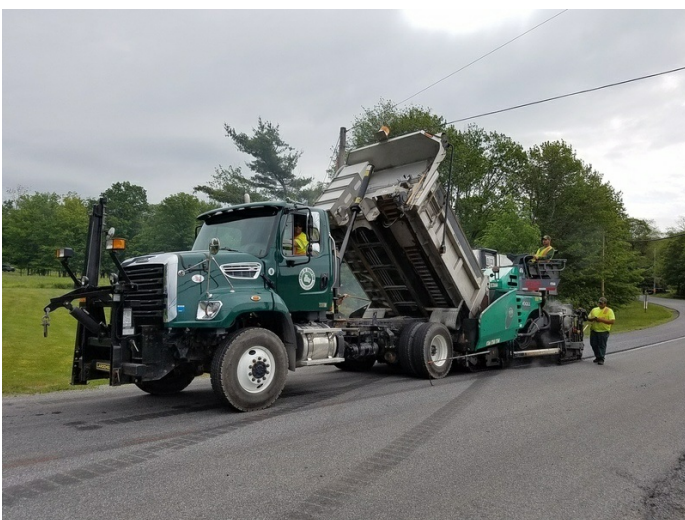
The Gorman Group paving with PPST Type B, utilizing the Town of Thompson to haul material

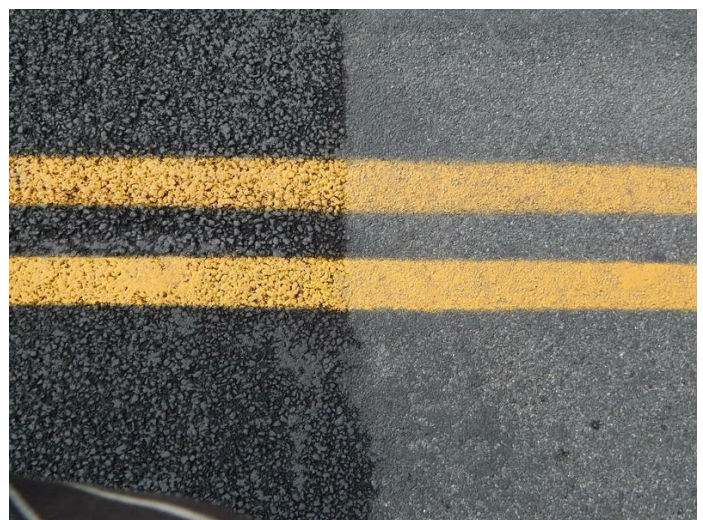
Finished Surface comparison - fiber reinforced interlayer with chip finish on right / PPST Overlay Finish on left
