Contractor successfully repaired Lake Louise Marie Road in the Town of Thompson located in Sullivan County New York. Fiber reinforced interlayer with a Paver Placed Surface Treatment overlay.

Town of Thompson , Sullivan County New York , heavy traffic load with predominantly semi tractor trailer vehicle loads.

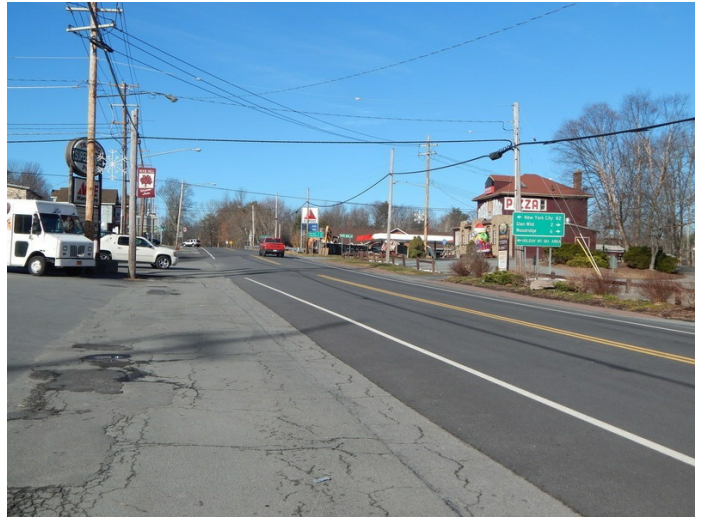
Lake Louise Marie Road finished with PPST Type B

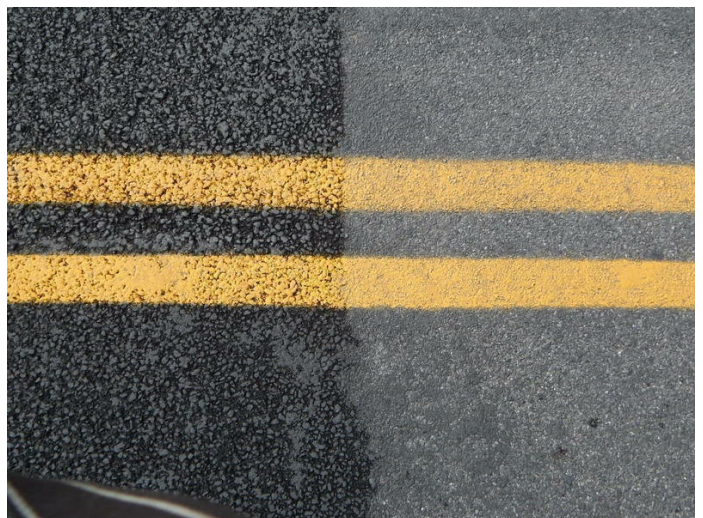
Finished Surface comparison - fiber reinforced interlayer with chip finish on right / PPST Overlay Finish on left
