Curry County saves their river road in shady, cool conditions thanks to the next evolution in Chip and Fog Seal Treatments.

## BACKSTORY:

The South Bank Chetco River Road in Curry County, Oregon sits near the Southwest corner of the Pacific coast. The road in guestion is in a constant battle with the elements, and budget limitations made a complete repave an unrealistic solution, leaving a specialized approach to Chip and Fog Sealing as the best option.

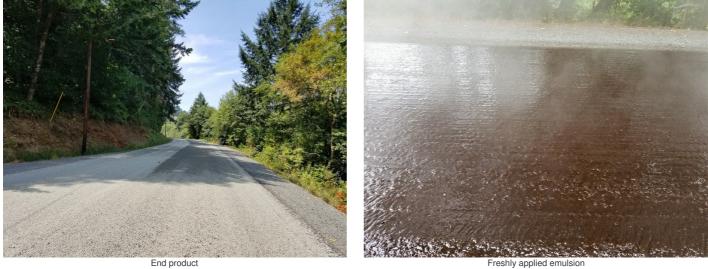
End product

In 2018, the town turned to Albina Asphalt to provide a specialized approach to chip sealing, using RS-LTP (A Rapid-Set Low Temperature, Polymer-Modified Anionic Emulsion), which can be applied at road surface temperatures as low as 40 degrees. This emulsion breaks chemically from the bottom up, and so does not require sunlight or heat to "break" -- making it the ideal emulsion for River Road's shady conditions. Once applied, the chip seal treatment filled cracks and provided a better driving surface on the road.

The three mile span was completed on August 8, 2018, taking only two days for the Chip Seal and one day for the Fog Seal. Two full winter cycles after completion, the South Bank Chetco River Road continues to hold up well, and is expected to last for a full decade through a variety of adverse weather conditions before additional treatments are needed.
